2022 303D Impairment List

To buffer or not to buffer

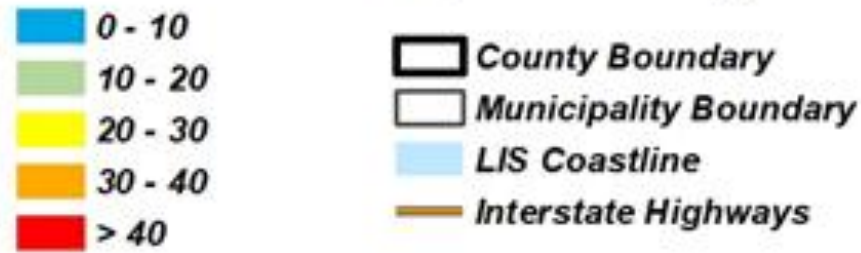
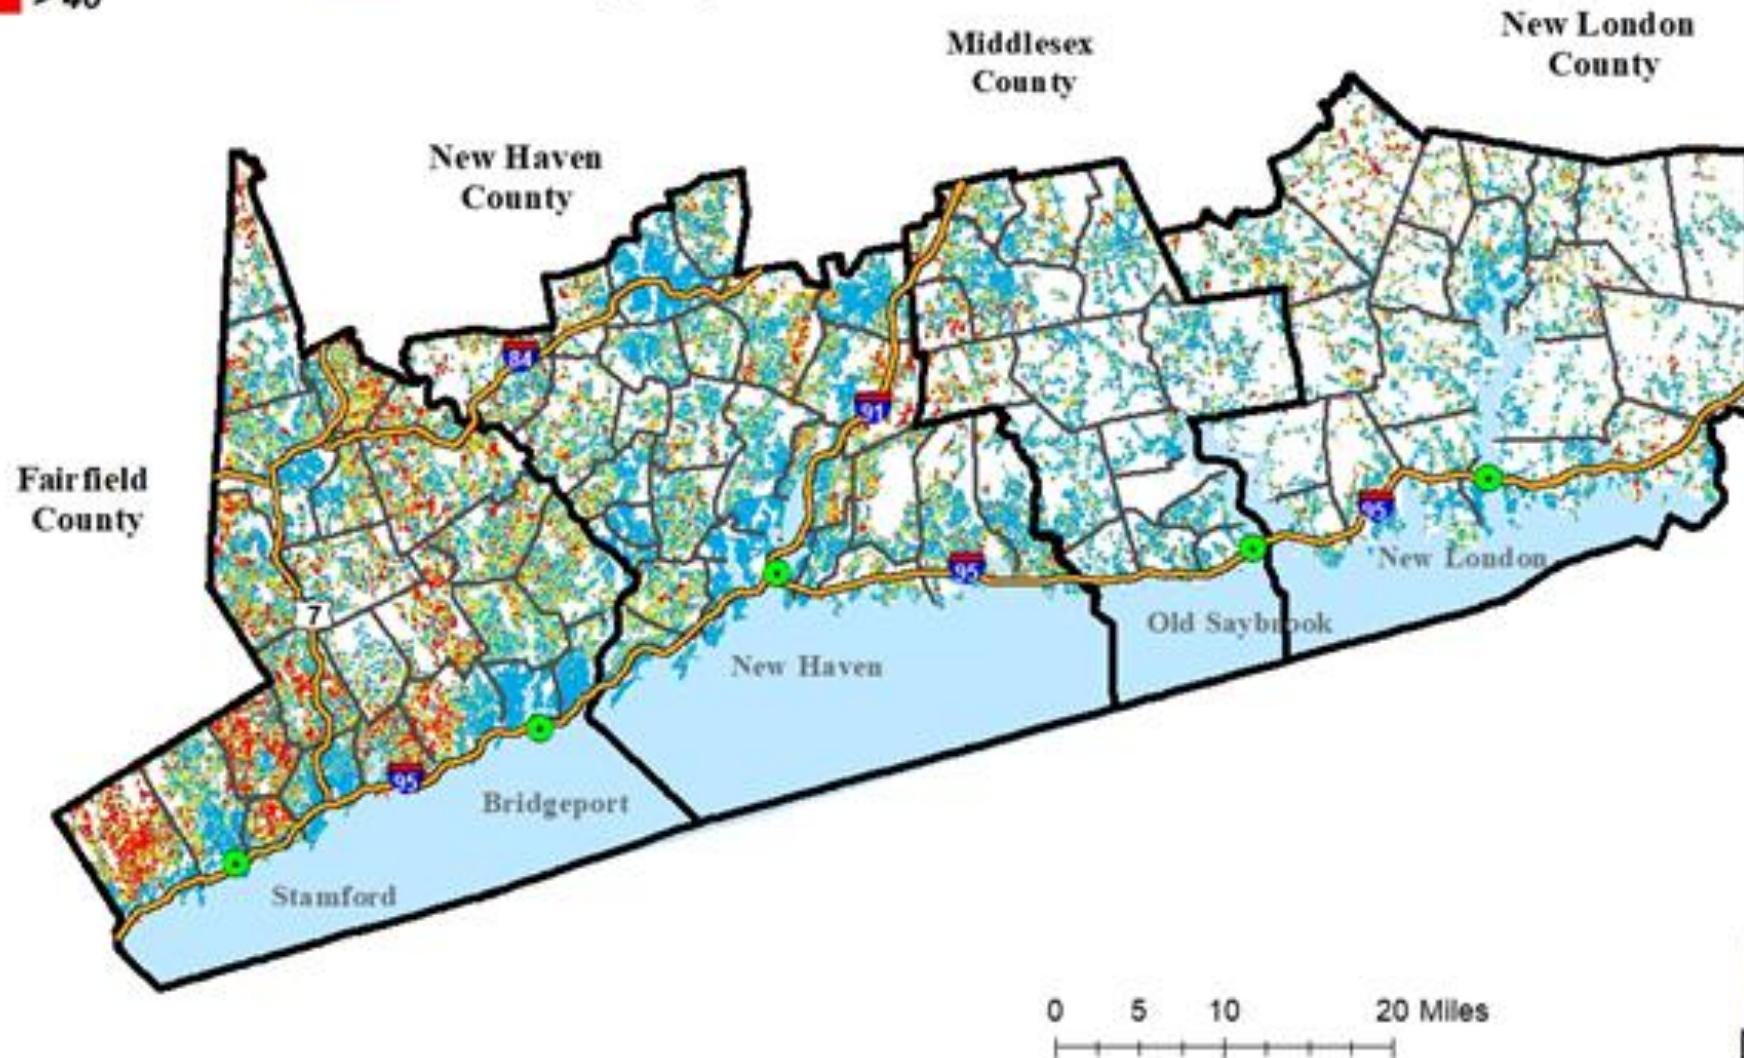
Predicted annual nitrogen fertilizer application (lbs/year)

Just these counties apply
4.5 million lbs. of fertilizer
each year along LIS

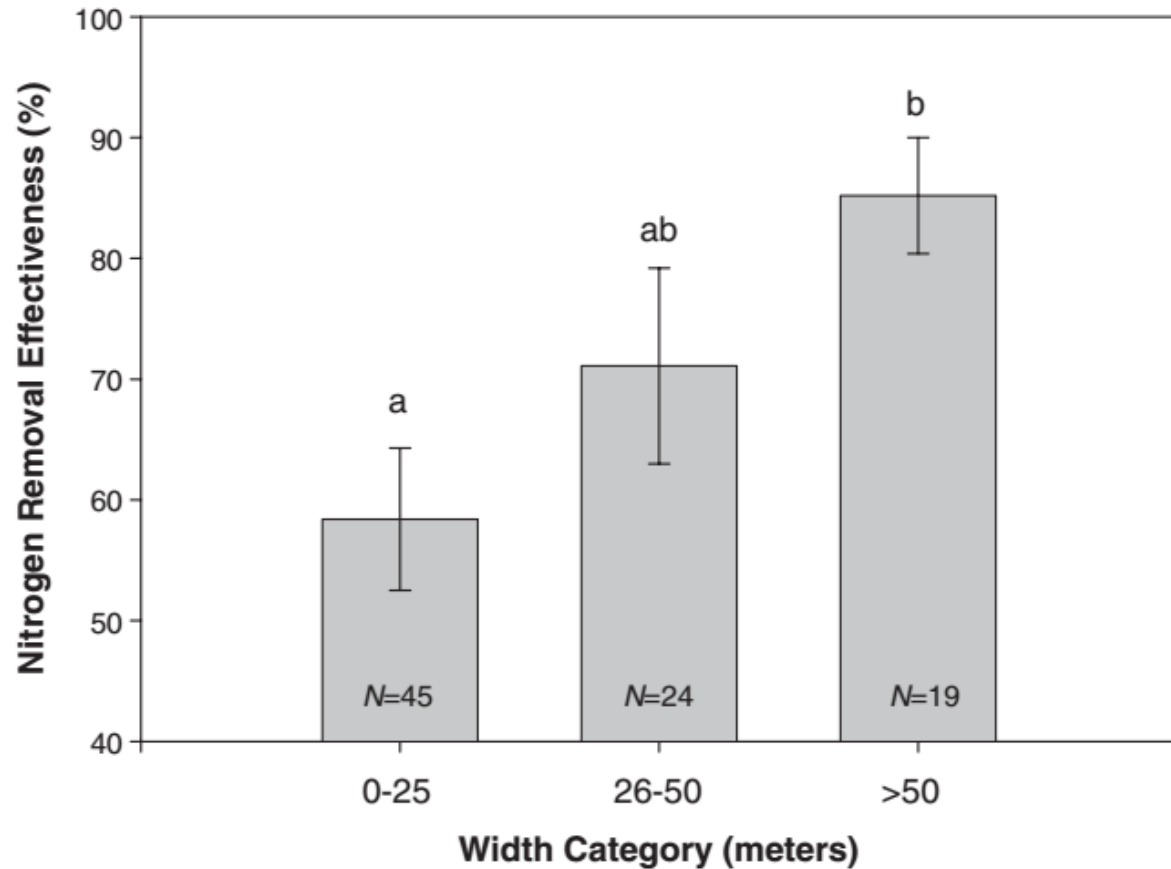
Fig. 2. Nitrogen removal effectiveness in riparian buffers by buffer width category. Bars represent means ± 1 standard error. Mean ranks of width categories differ if denoted by different letters (Kruskal–Wallis one-way analysis of variance on ranks with Dunn’s method of multiple comparisons, $P < 0.05$).

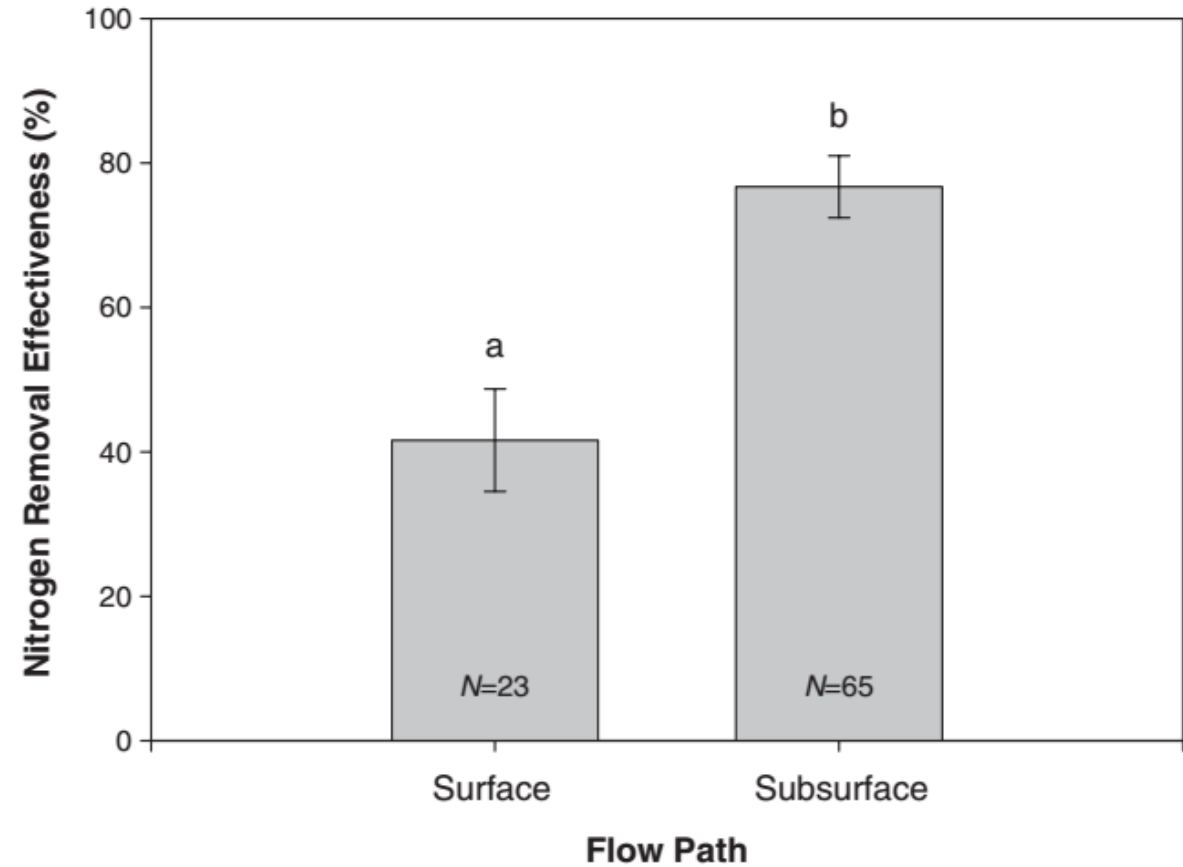
Fig. 3. Nitrogen removal effectiveness in riparian buffers by water flow path. Bars represent means ± 1 standard error. Mean ranks of flow paths differ if denoted by different letters (Mann–Whitney U test on ranks, $P < 0.001$).

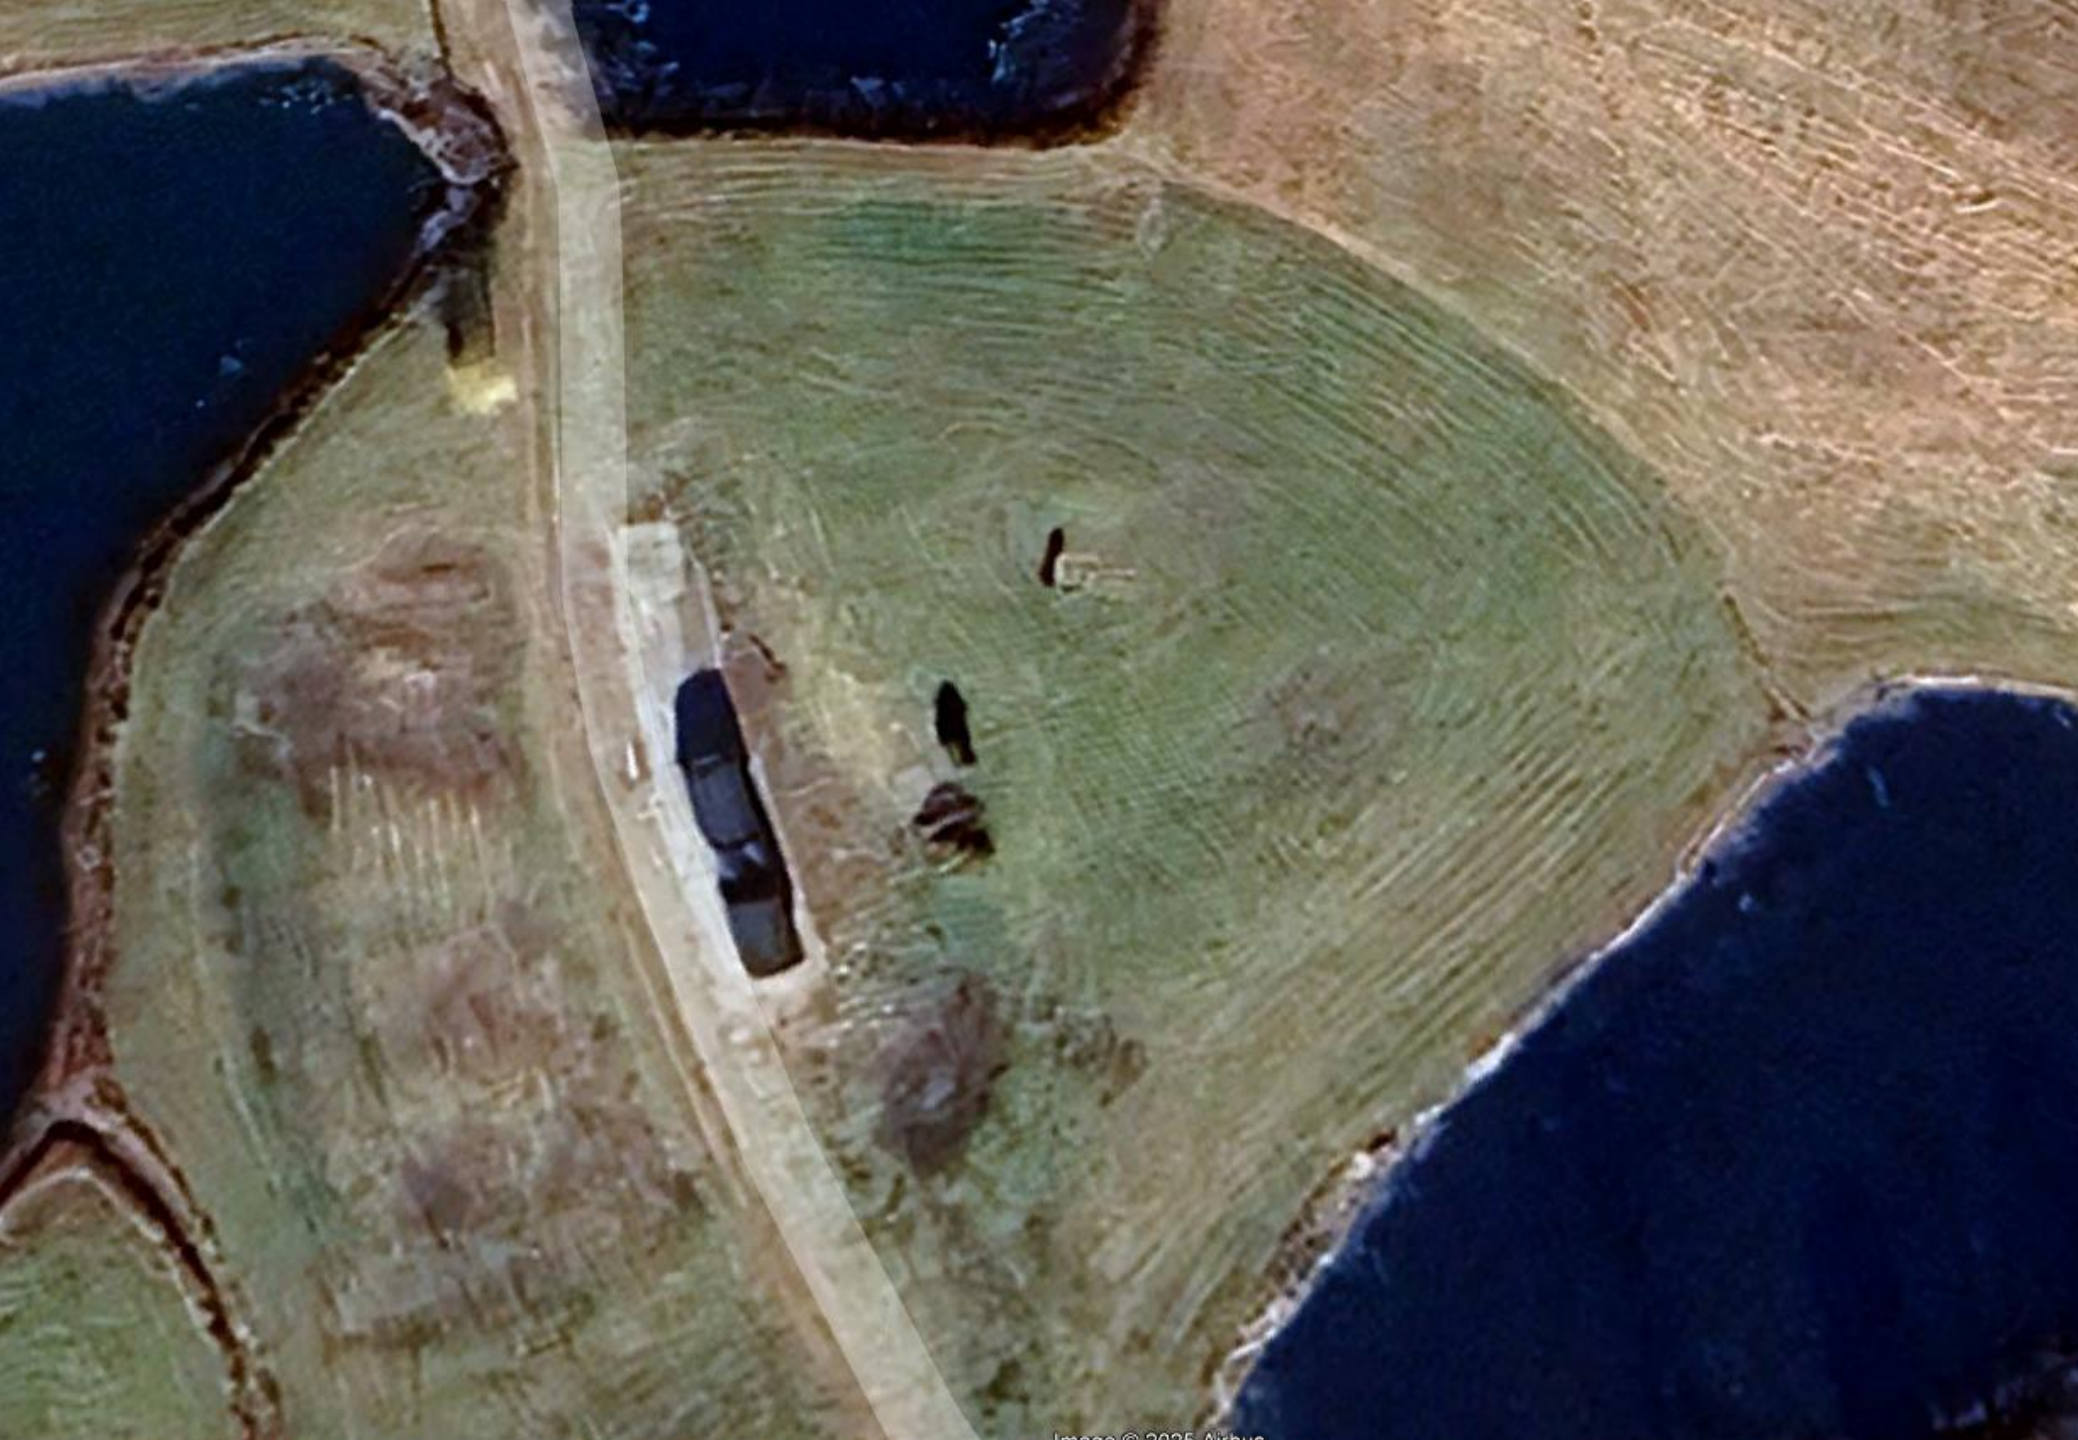
Series of low
buffer
Ponds leading into
Deep River

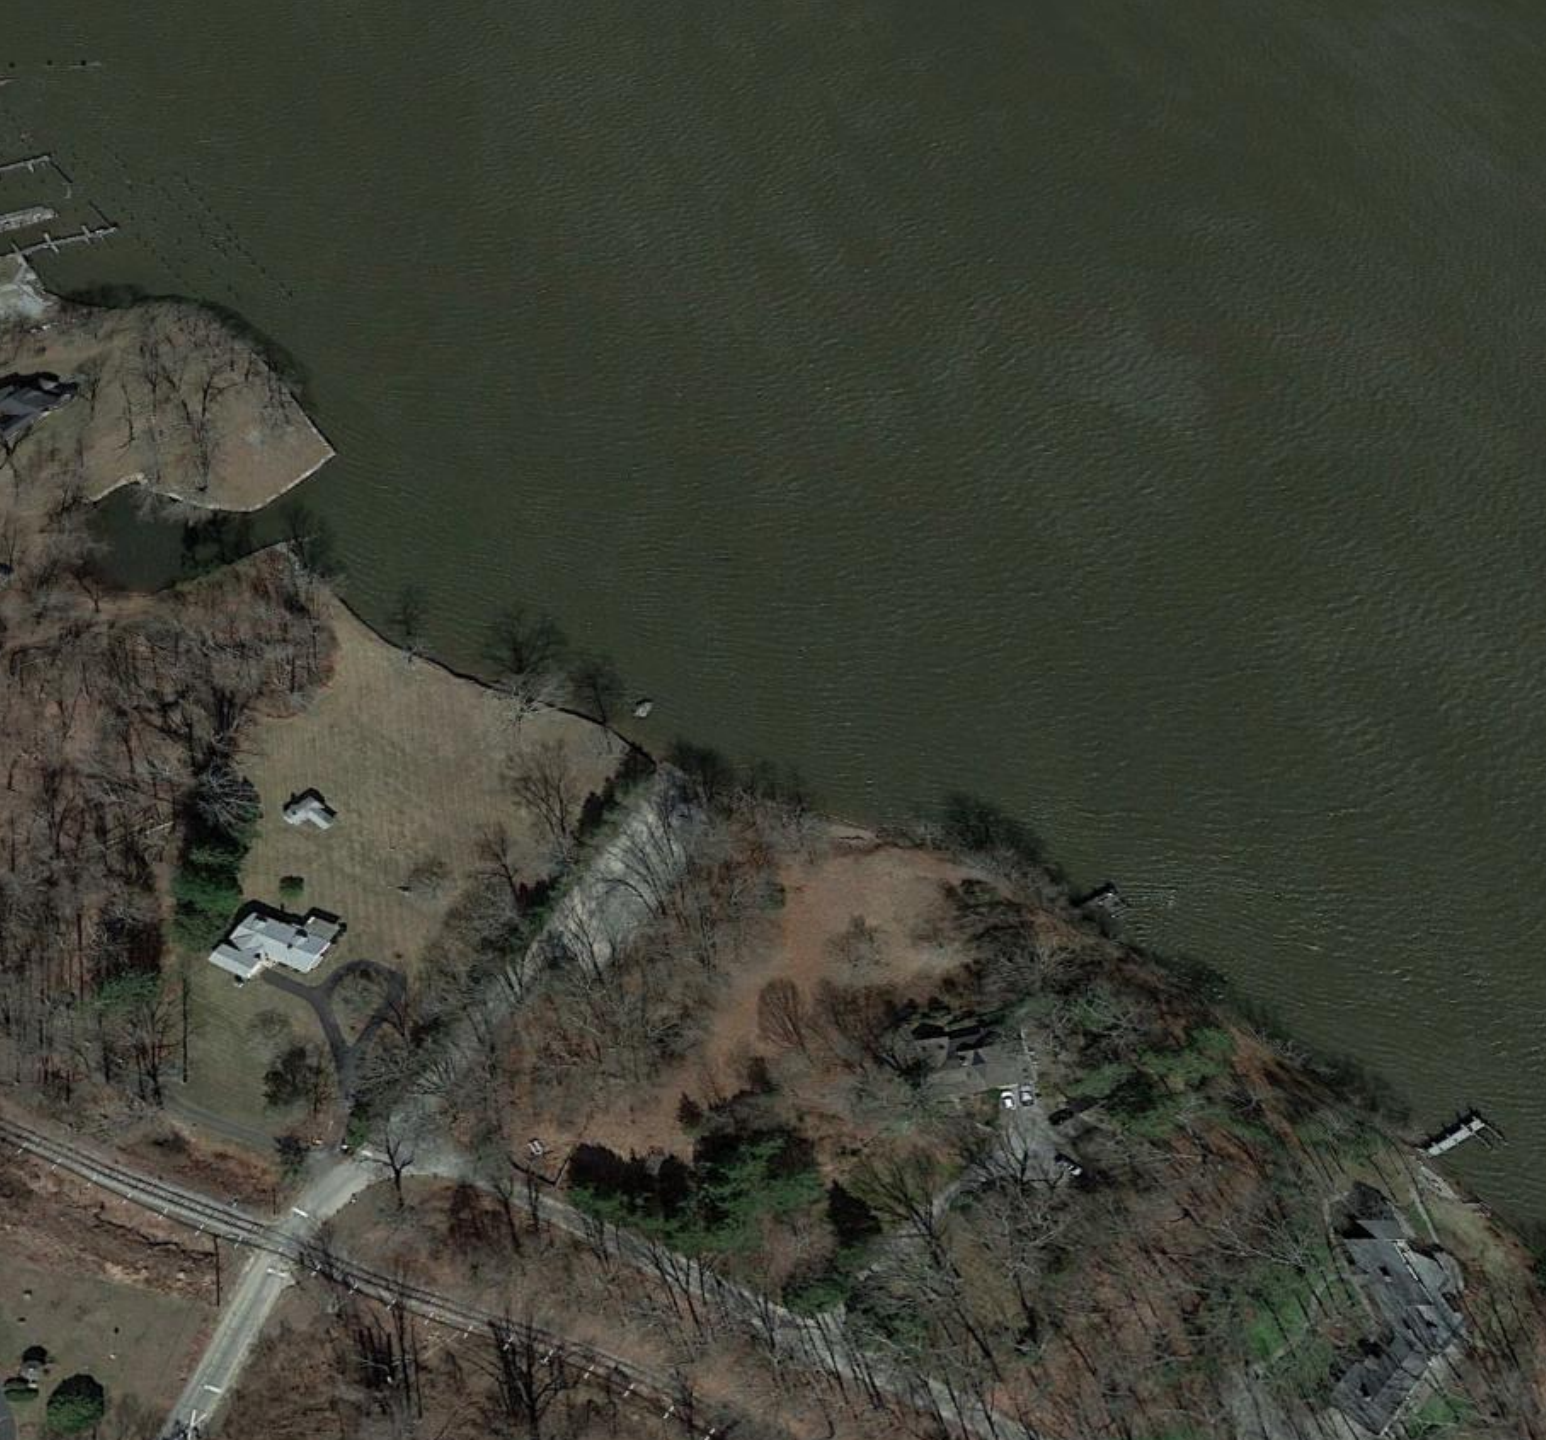
Fertilized lawns straight to the water's edge

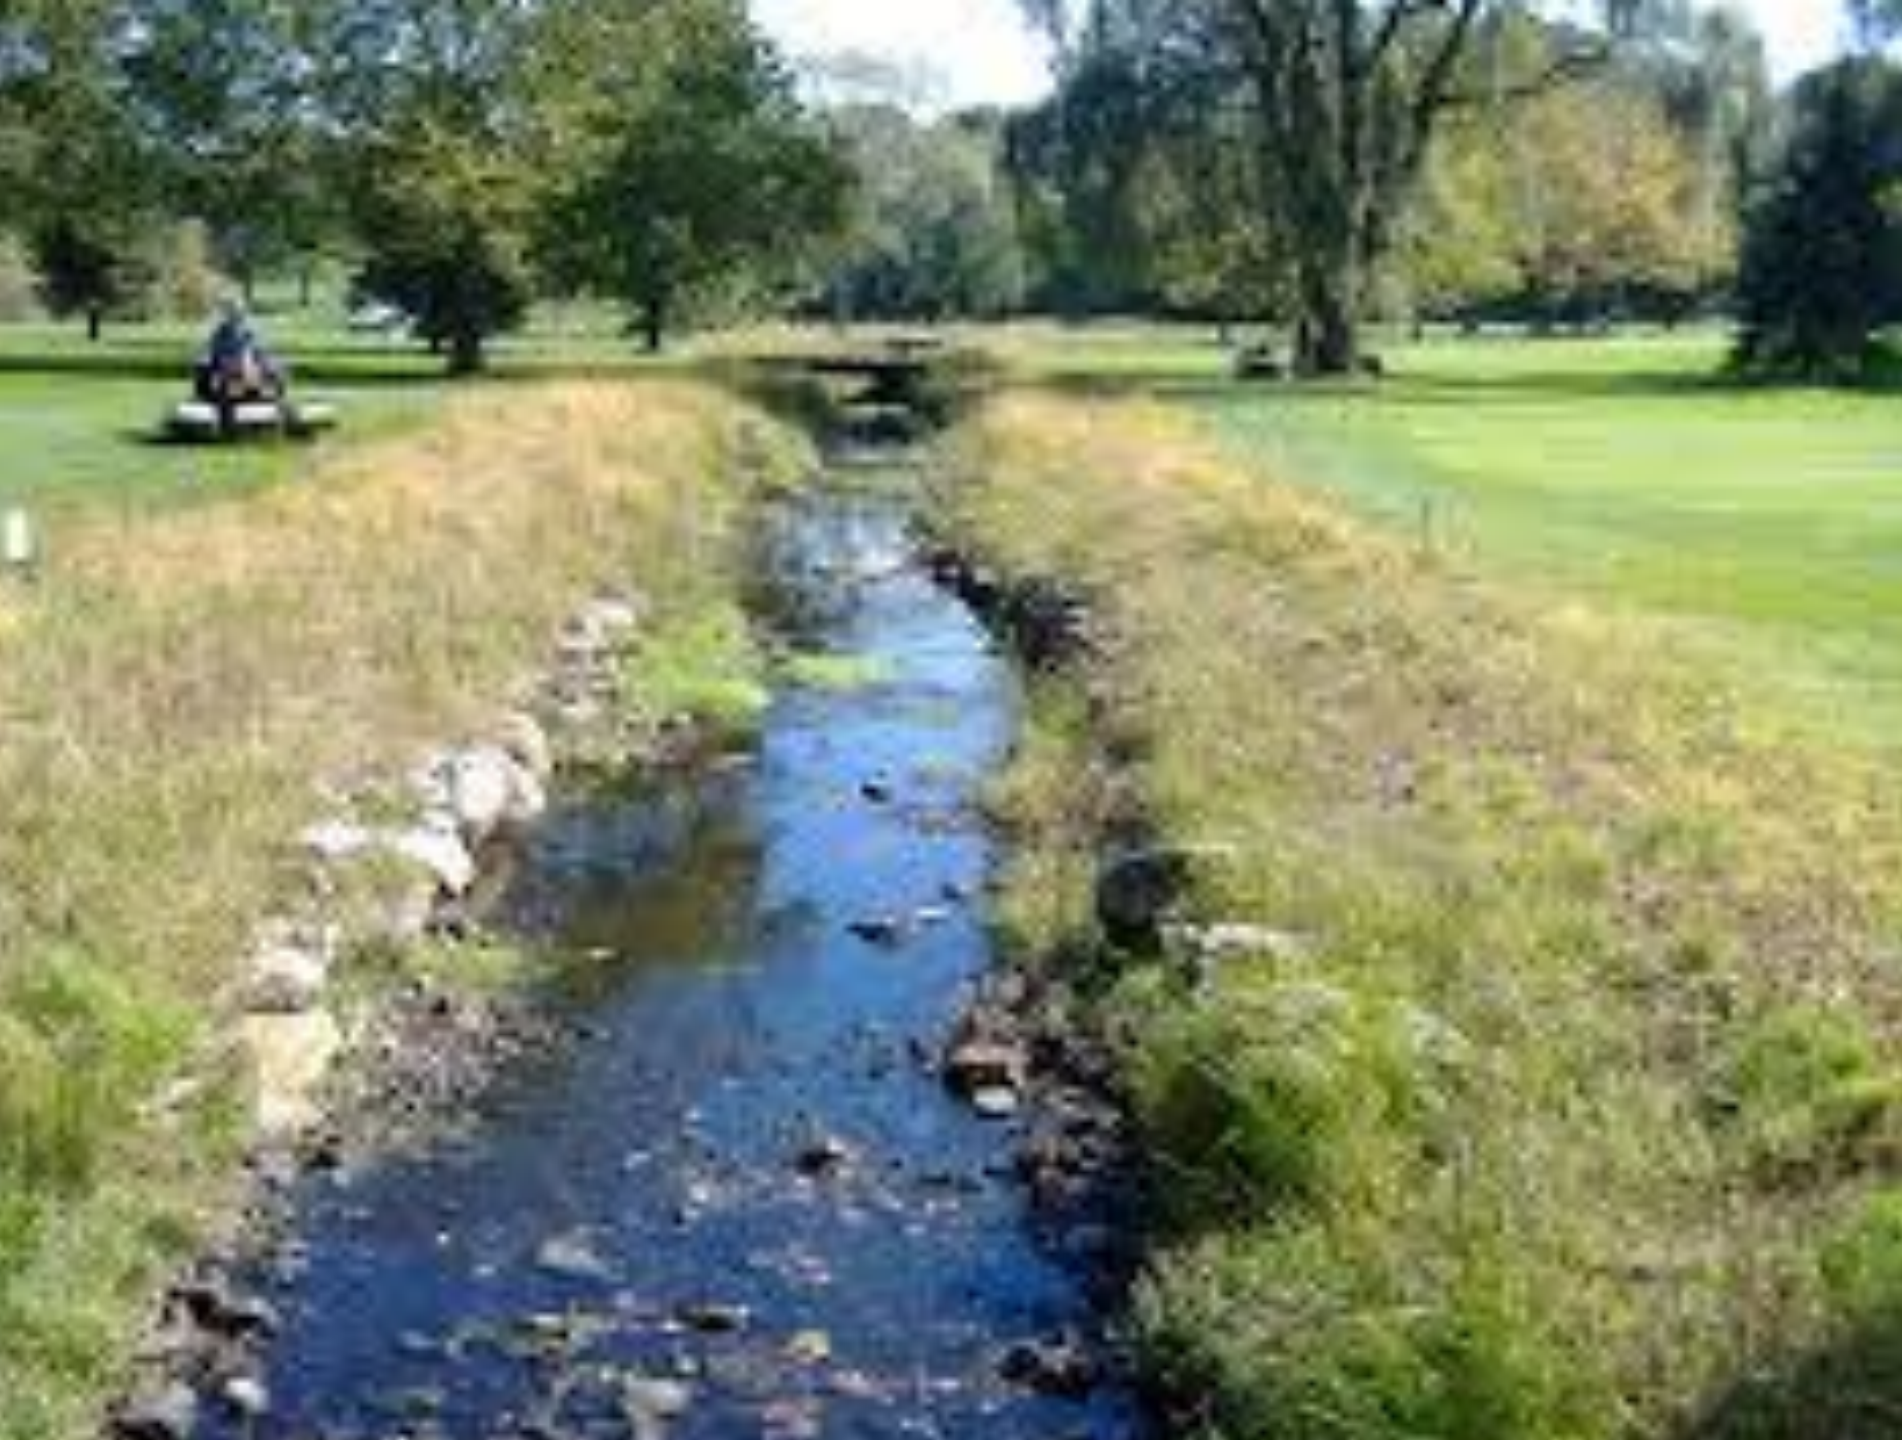
Westchester County
No mow strip

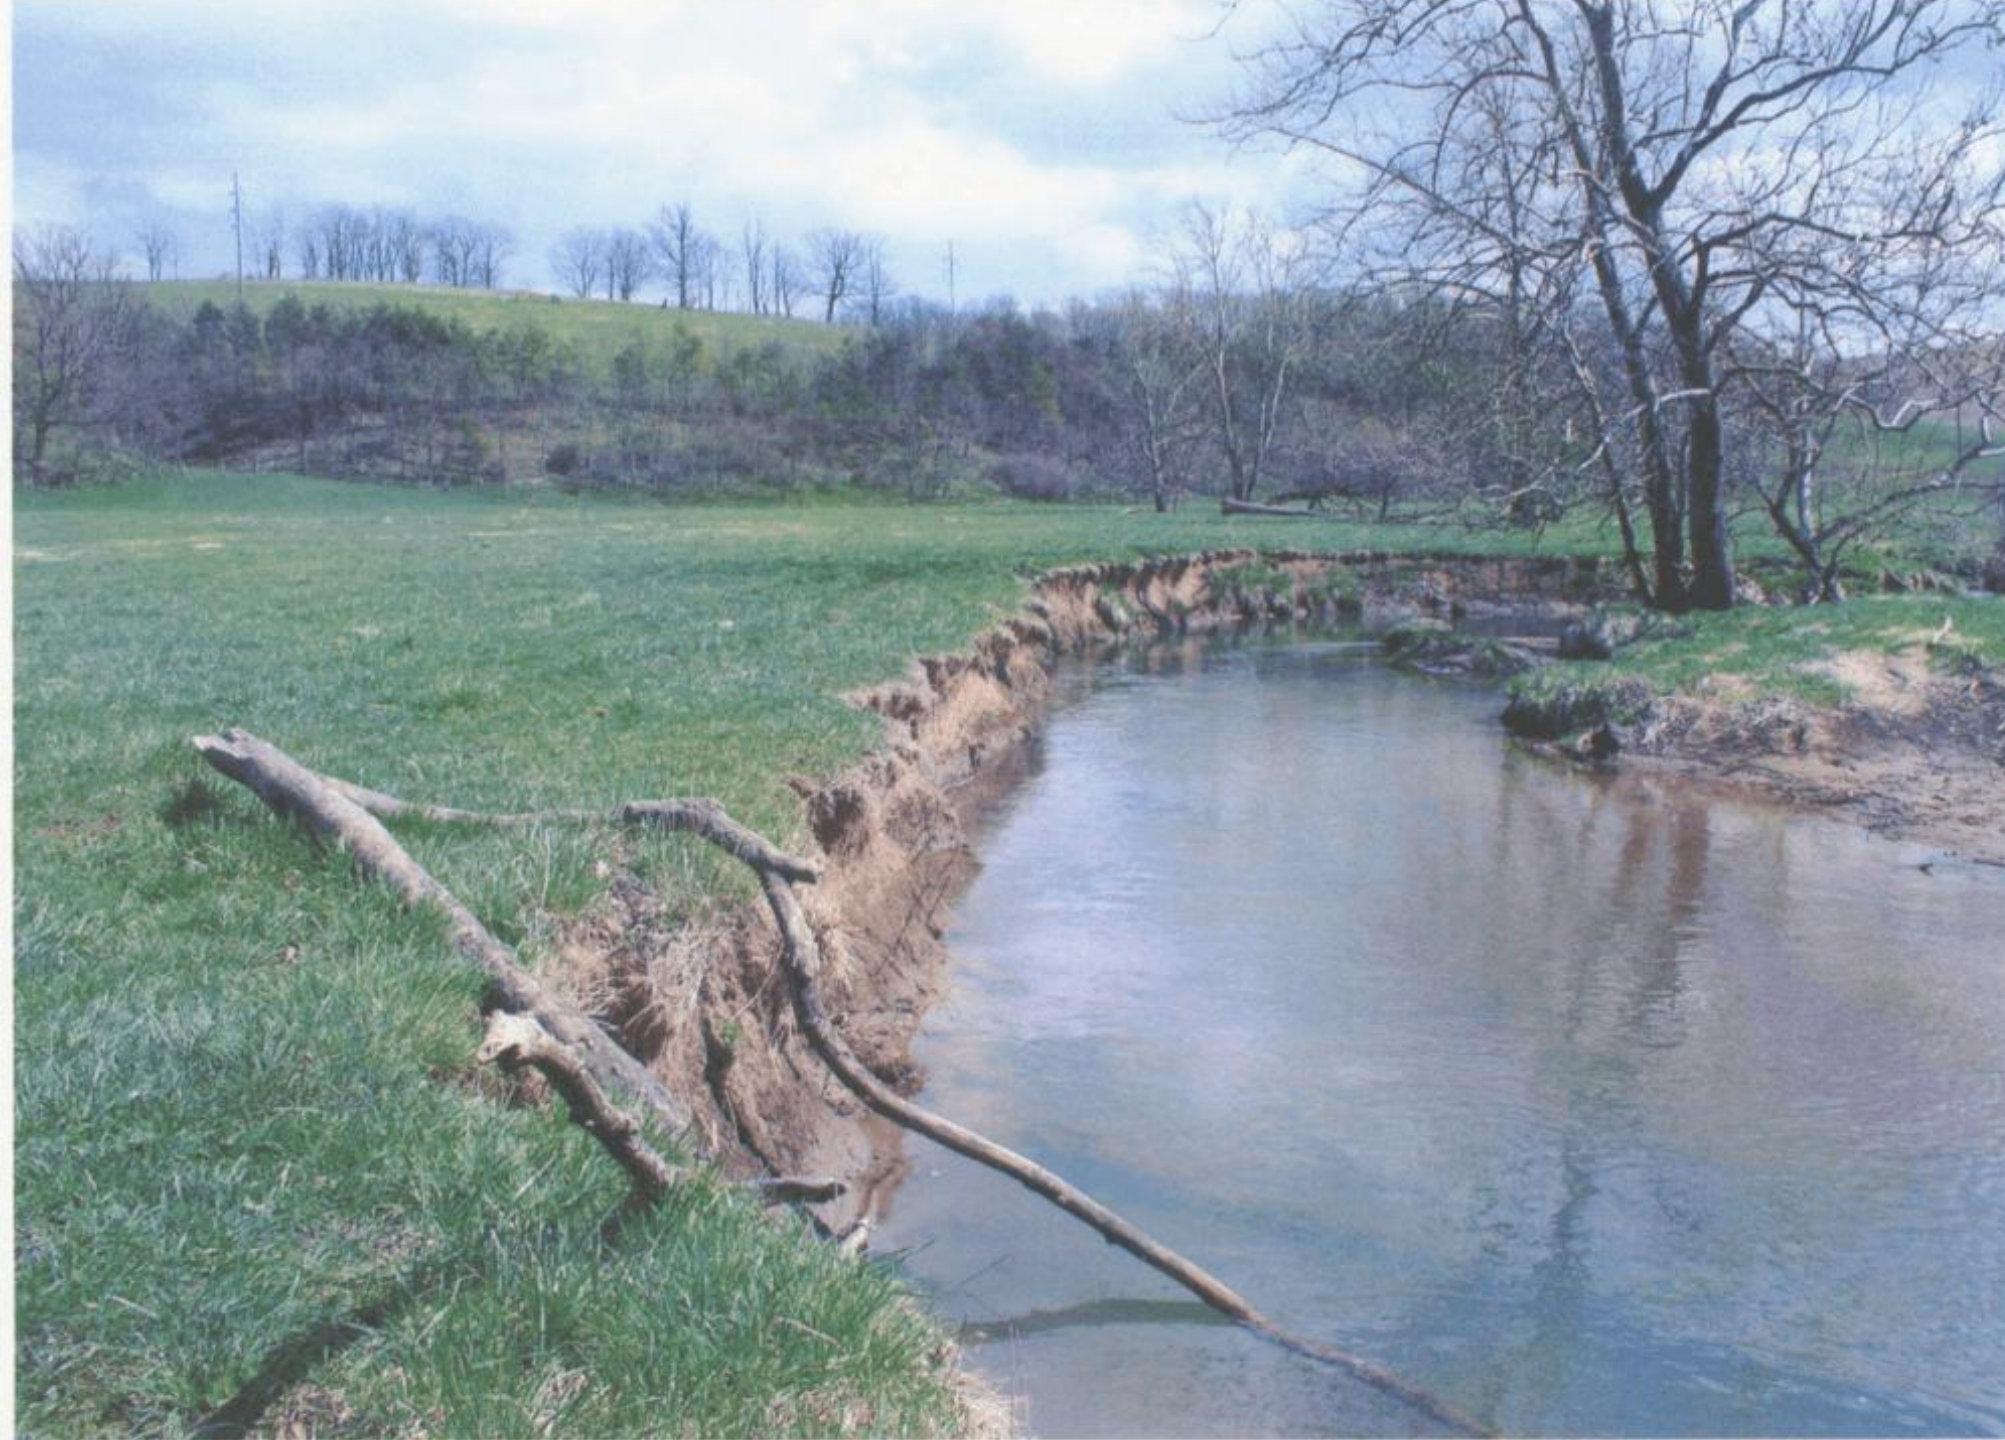
Degraded banks

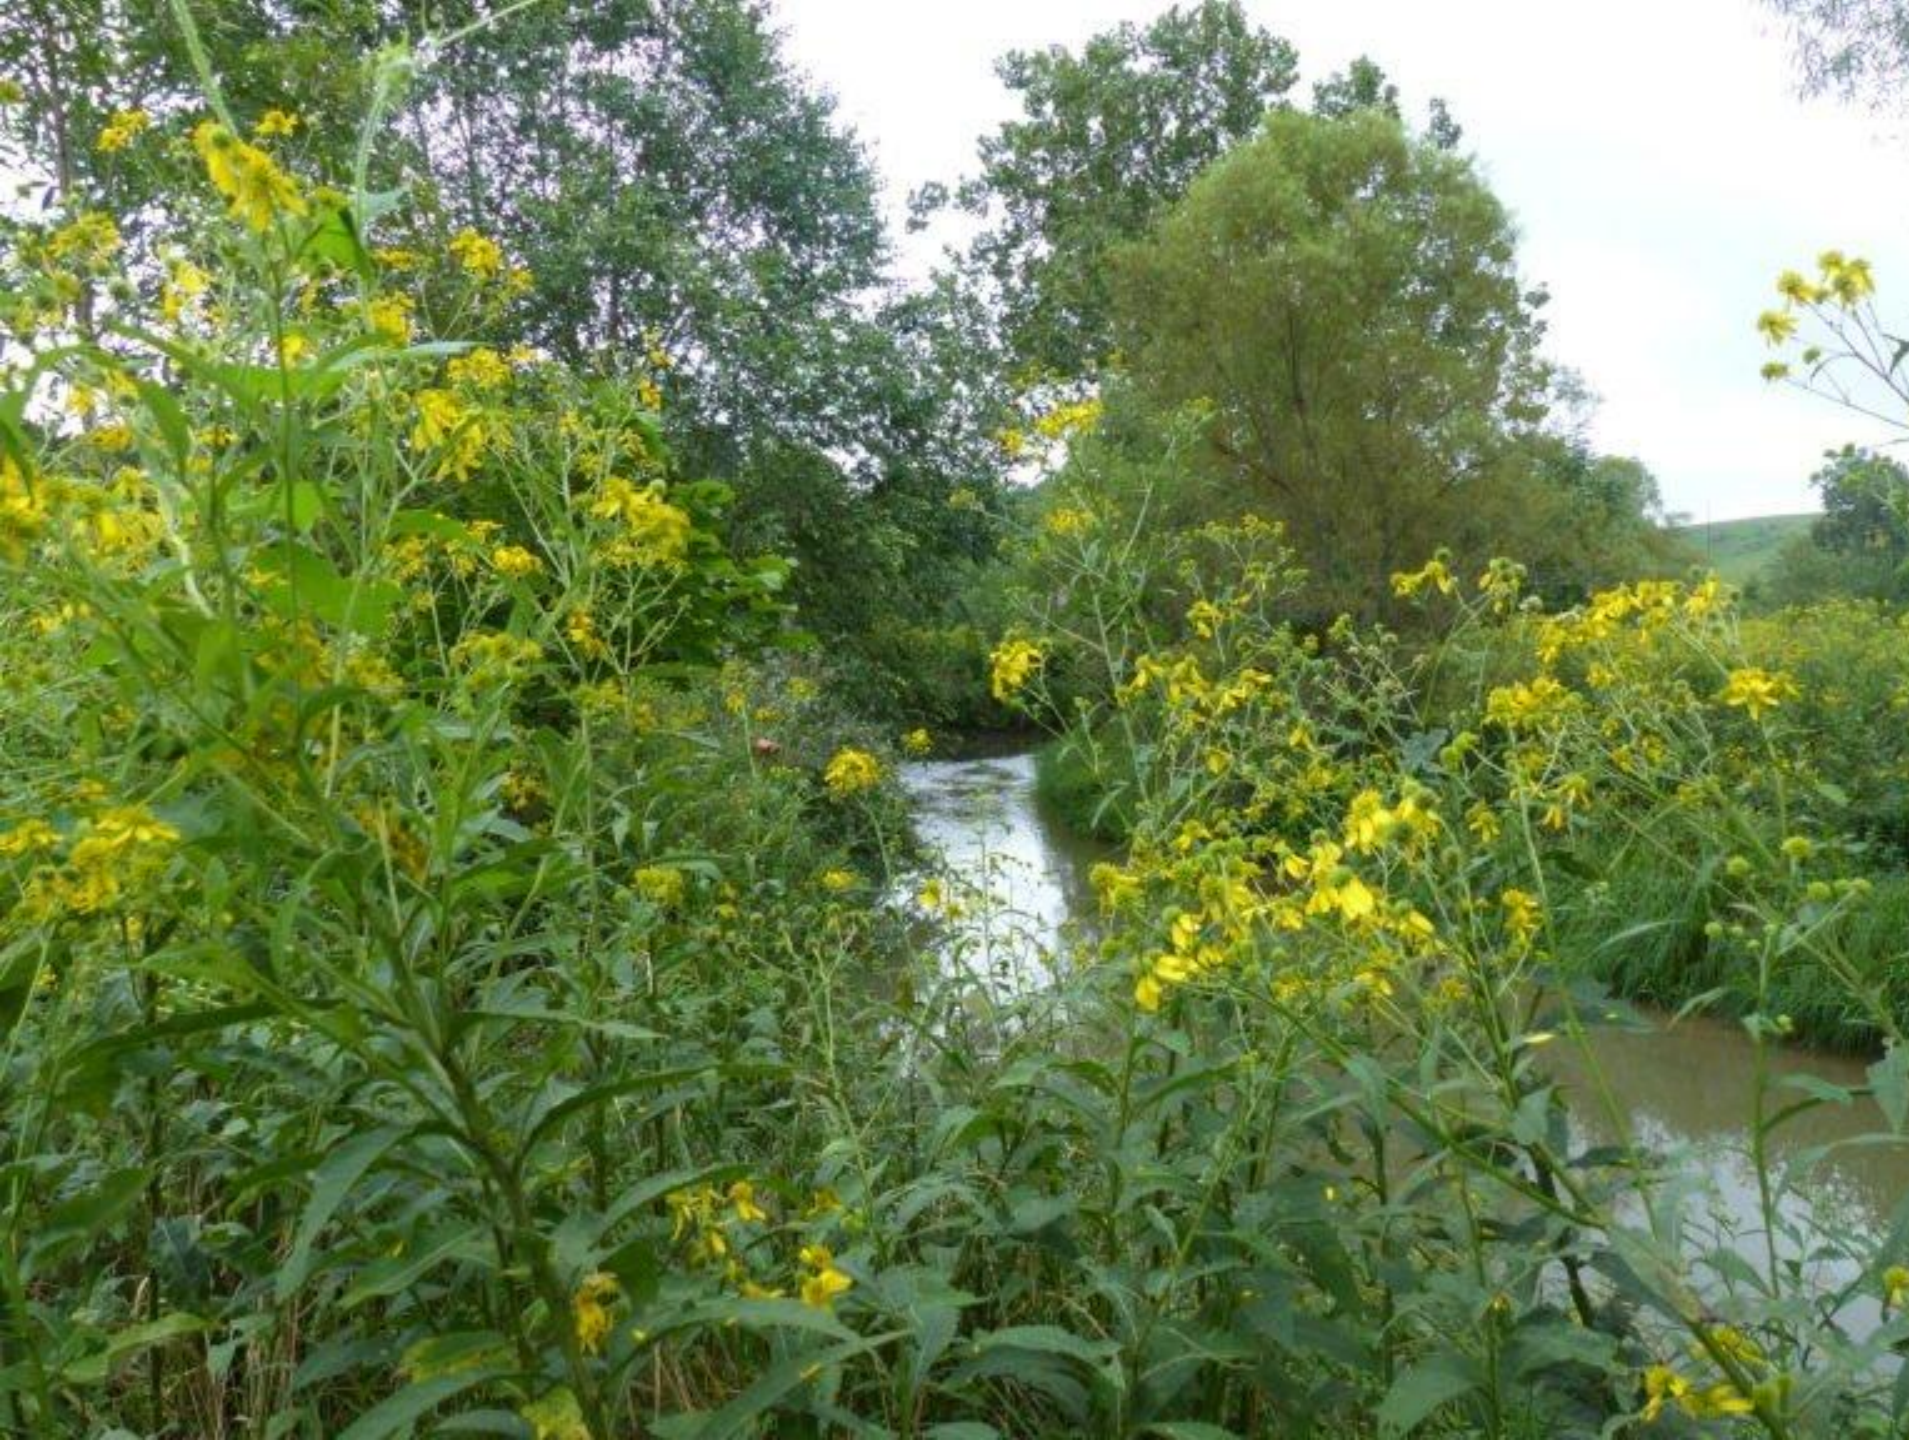
Same view three years later

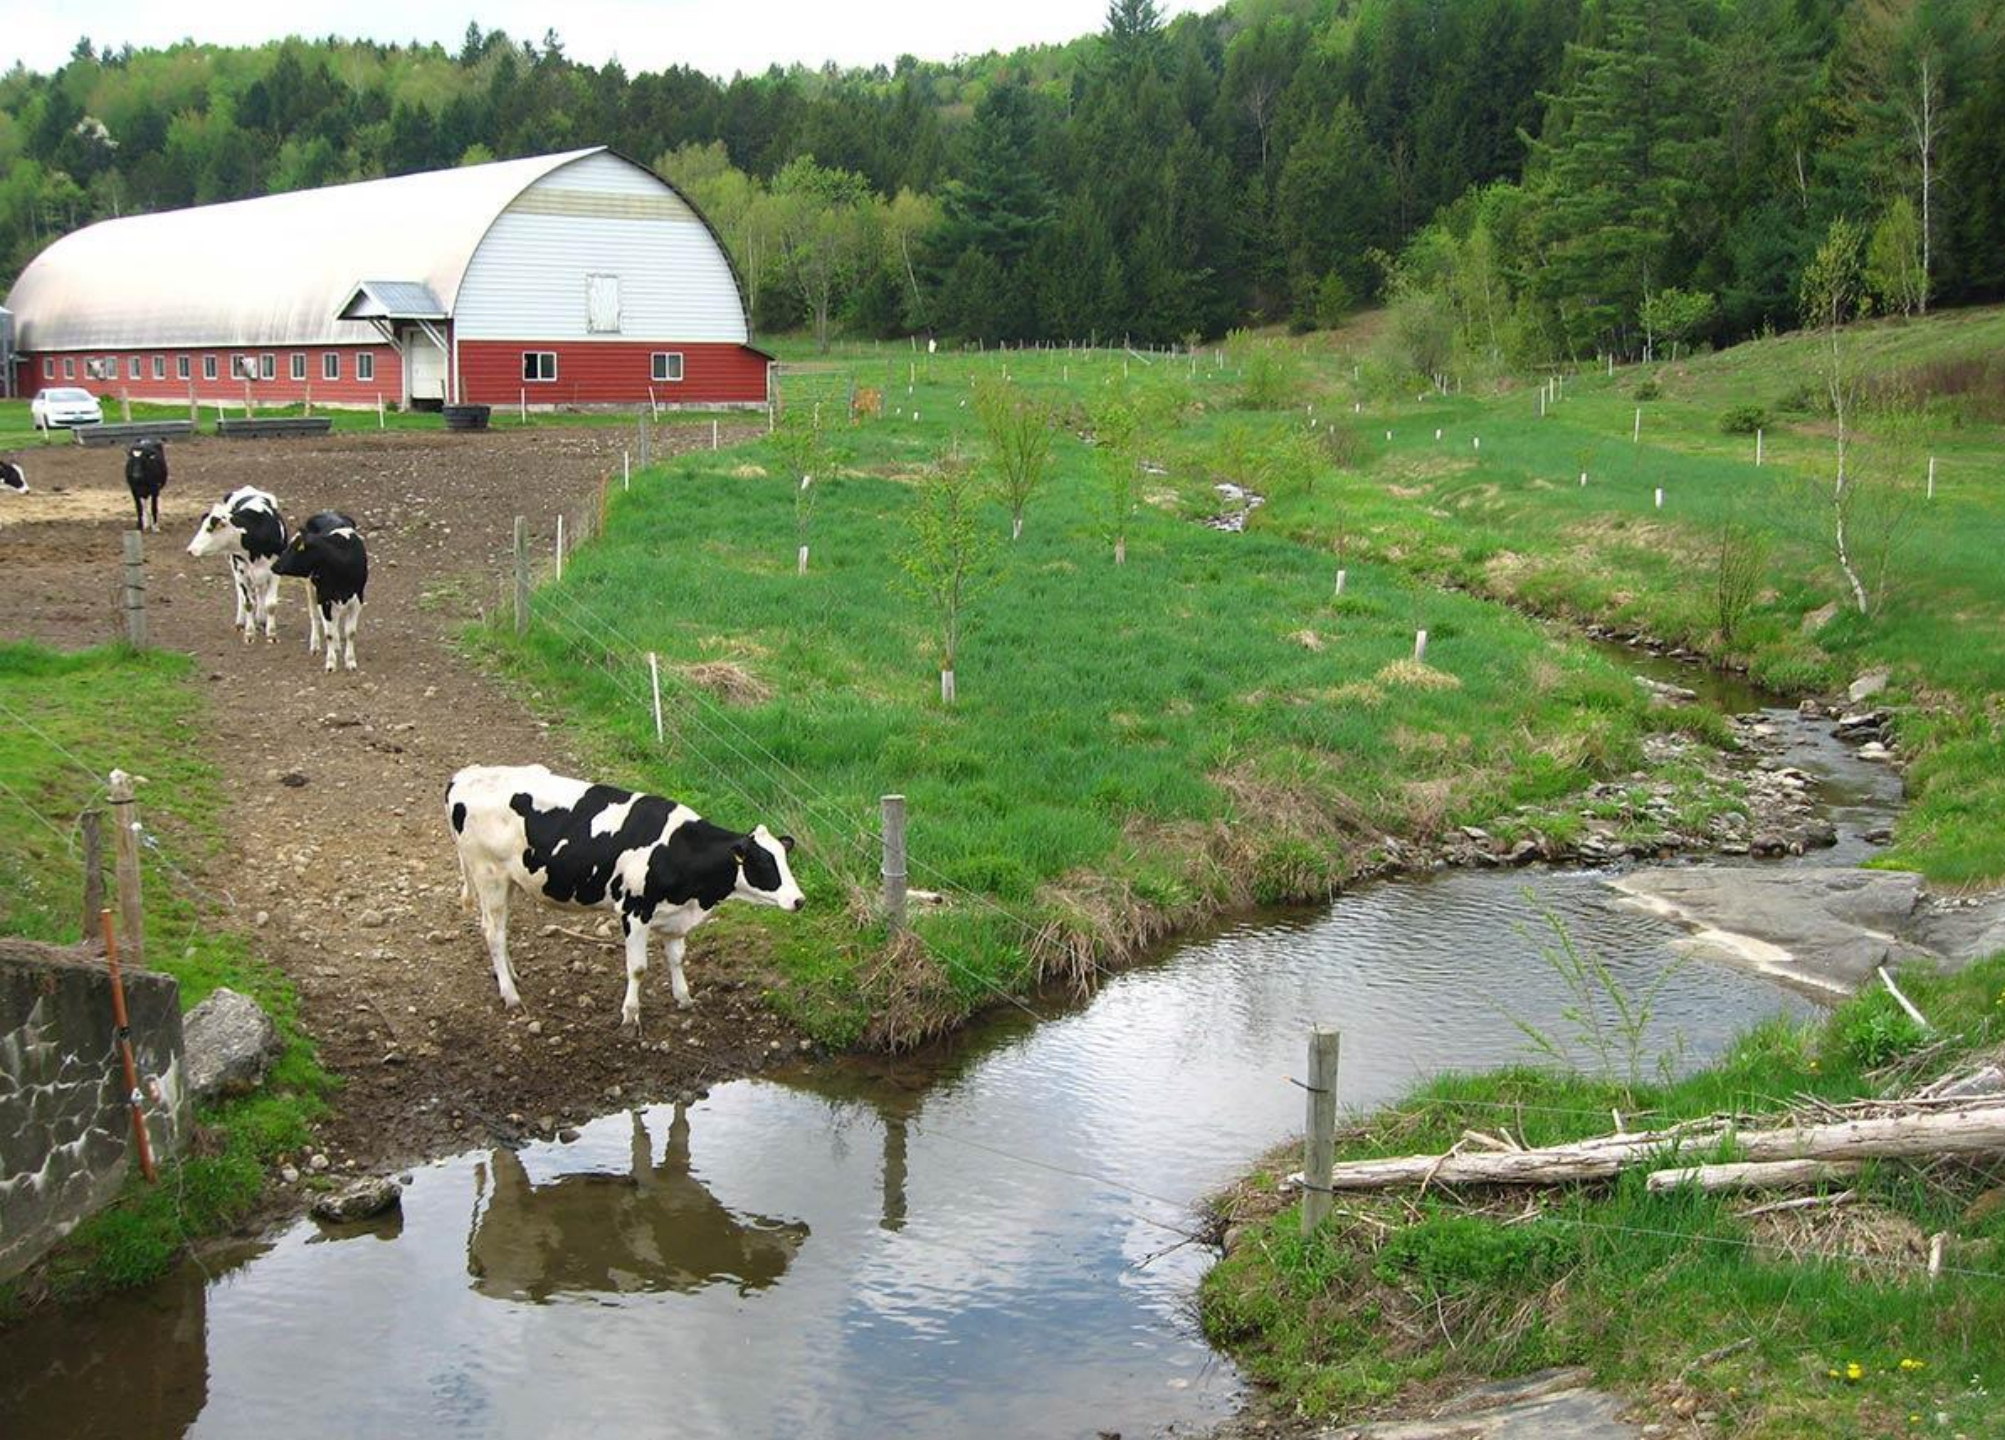
Restoring degraded
Pasture and Riparian
Area while maintaining
ford to adjacent
pasture
